## 2022 State Board of Equalization

**File No.:** 2022-WILLIAMS-CAPITAL GAINS

**Issue:** Appellant appeals commercial property valuation.

**REAL ESTATE APPRAISAL**

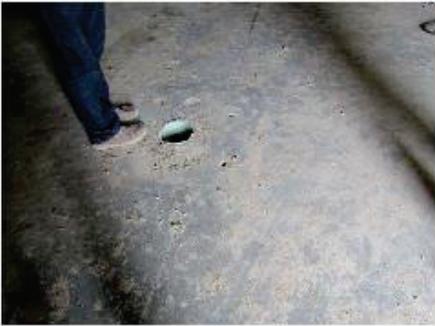
**Main Water Supply Removed**

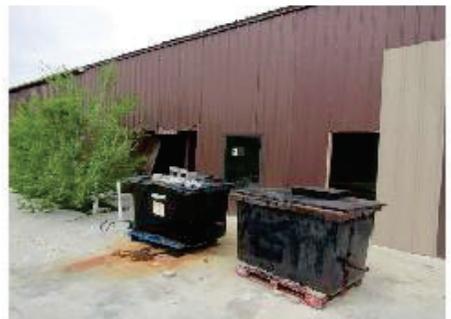
The subject property is a light industrial building once used for unheated storage use. At the time of inspection, it appears that the insulation was dislocated in places throughout the ceiling since the property was vacant for several years. The overhead sectional door was knocked off the track and laying on the floor. There was also damaged siding on the south side of the building.

**Wall Damage**

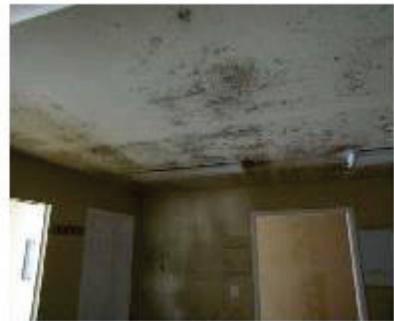
The subject property is a light industrial building once used as storage and office. At the time of inspection, it appears that the insulation was dislocated in places throughout the building since the property was vacant for several years. The office area in the building would likely have to be razed as most of the walls and ceiling have black mold. There is a storage mezzanine above the office at the rear of the building.

**Mold In Office Areas**

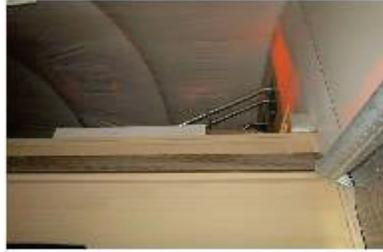
The subject property is a hoop building that was originally utilized for a meeting place/recreation/dining for occupants at the complex. Based on the inspection the property exhibits several signs of deferred maintenance to the point that the building likely does not function as it was originally intended. Some of the deferred items include detachment of insulation in the exterior walls, unknown working condition of the entire mechanical system, and possibly mold on interior walls. There is no water because the system was dismantled. Connected to the building is 3,780 sq. ft. and 20 ft. walk through. This is a metal insulated building with 9 ft. sidewall height. It has a steel frame, HVAC system, some interior finish. This part of the building was considered average. THE HOOP BUILDING WILL BE GIVEN NO VALUE IN THIS REPORT.

**Ceiling View/Seperation**

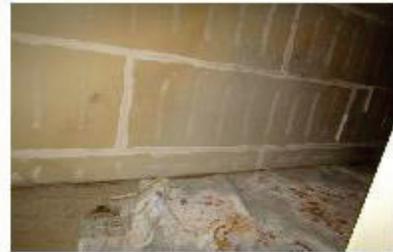
**Interior Mold Damage**

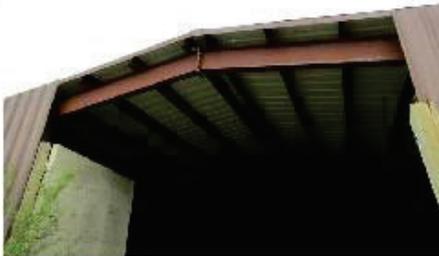
The subject property is a metal building that appears to be used as storage. This is a basic metal building. The main door and frame appear to have been damaged.

**Damaged Door**
